Manhole Inspection Summary

Manhole # S37II1030MH

Location Address: **518 41ST ST**

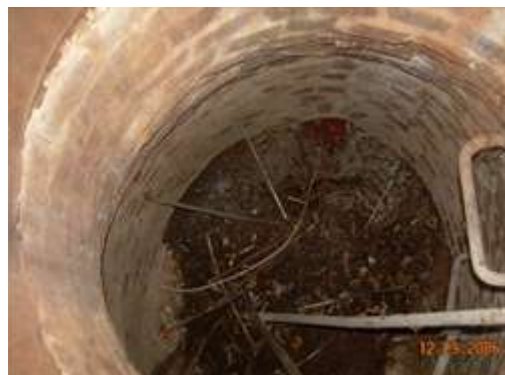
Top View

Frame leaks. Adjustment and Barrel infiltration. Channel debris

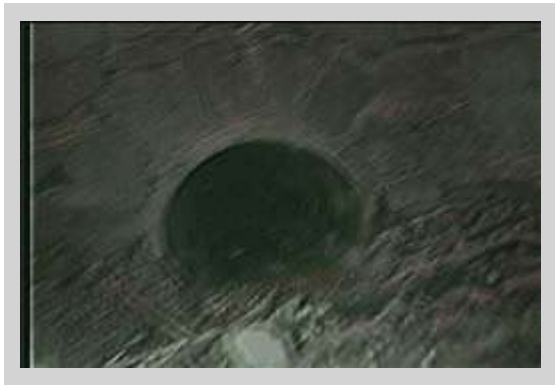
8 in. Circular Gravity Sewer
Pipe Out @ 12 O'Clock

Deposits: ☐ None ☒ **Mud** ☐ Sludge ☒ **Debris** ☐ Grease

Silt Depth: **1** (in.) Deposits Extent: **Light**
